GARDNER CREEK DAM

NDS ID NO. PA-00575

PHASE I INSPECTION REPORT

NATIONAL DAM INSPECTION PROGRAM

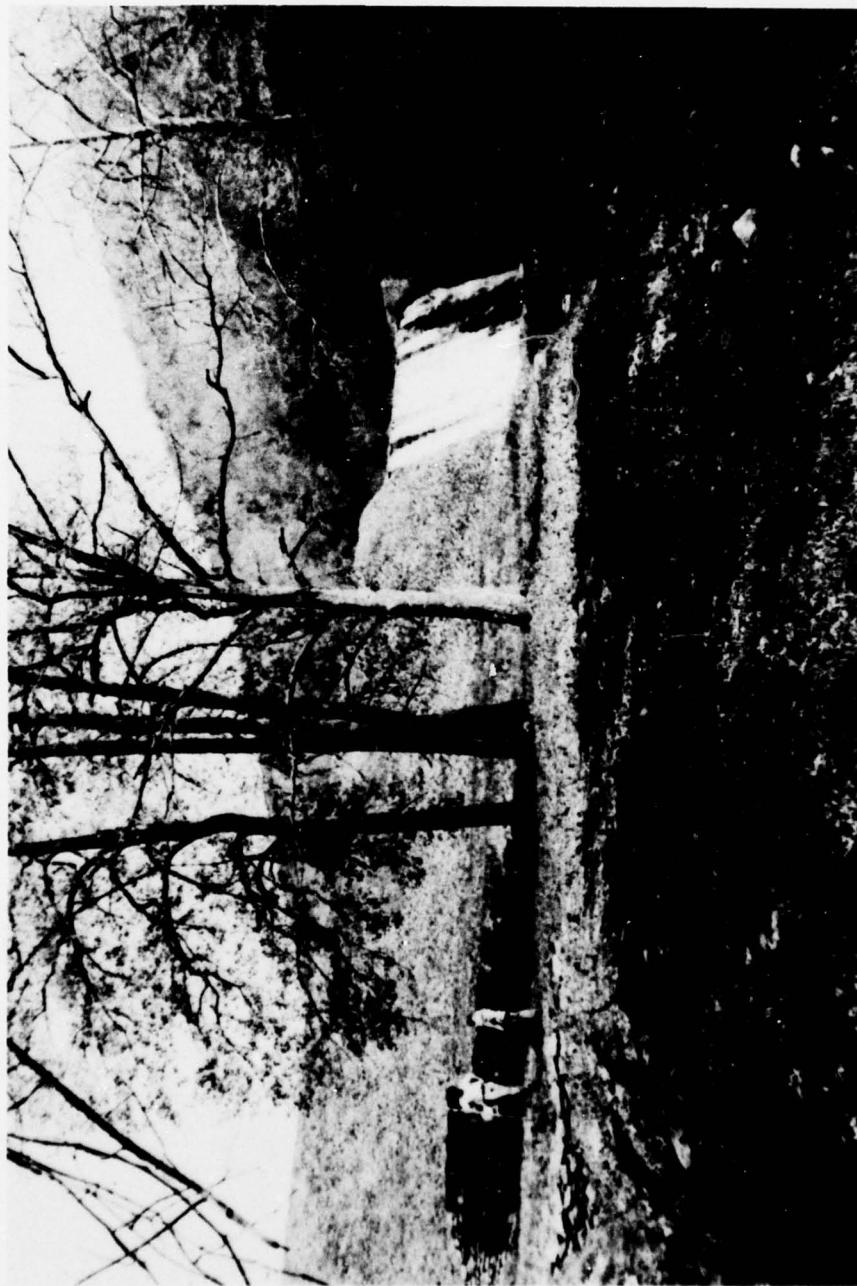
Embankment, Spillway, and Gatehouse
Looking Upstream

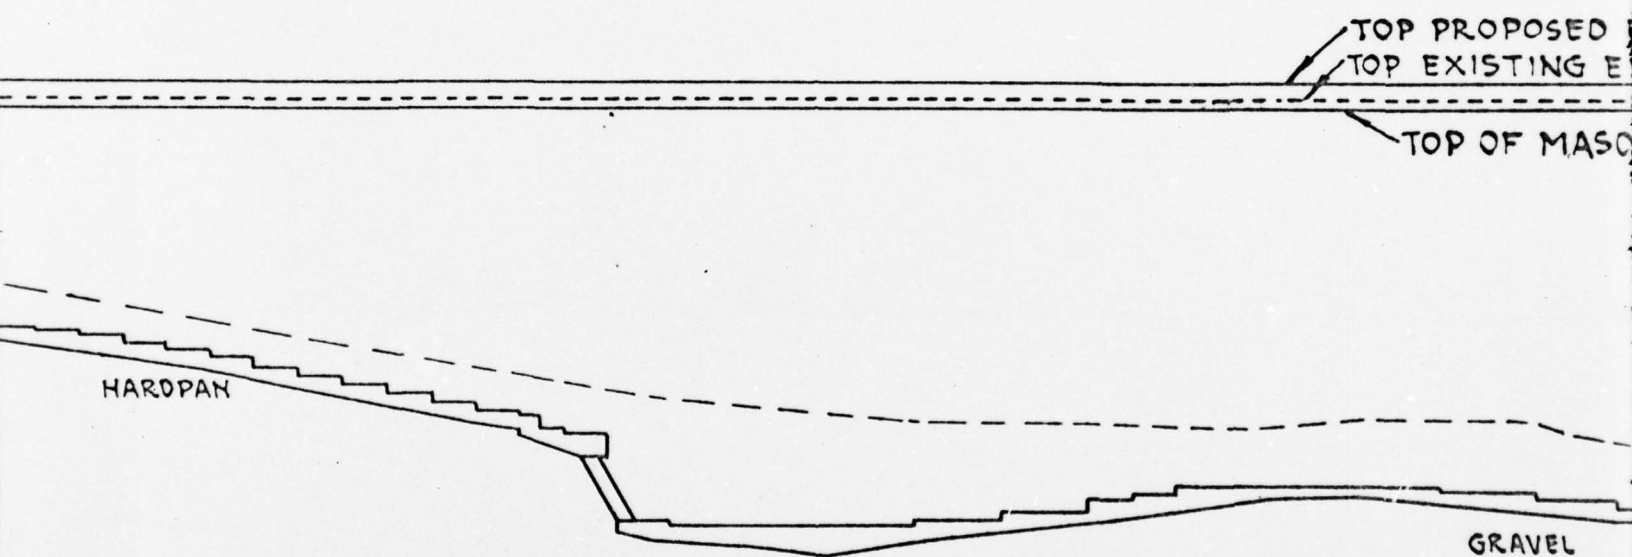
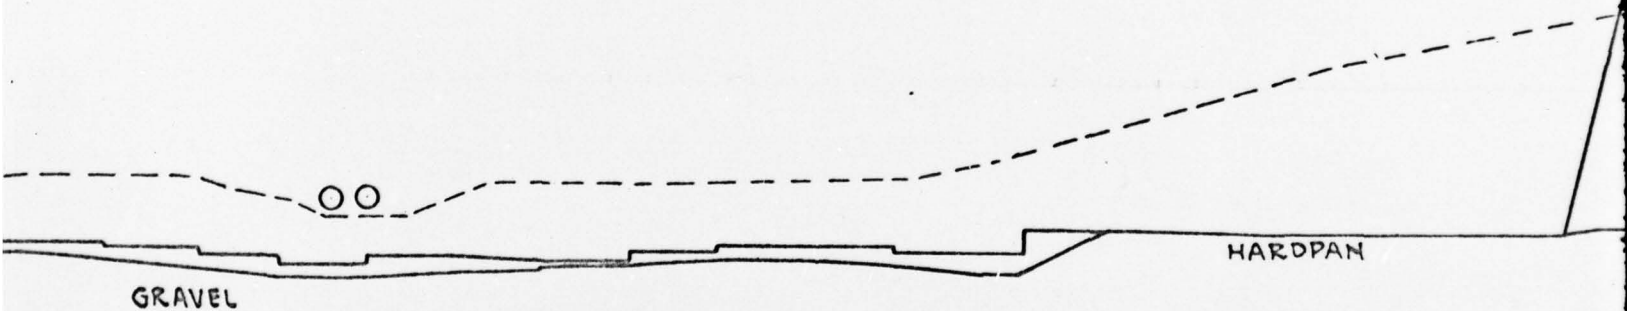
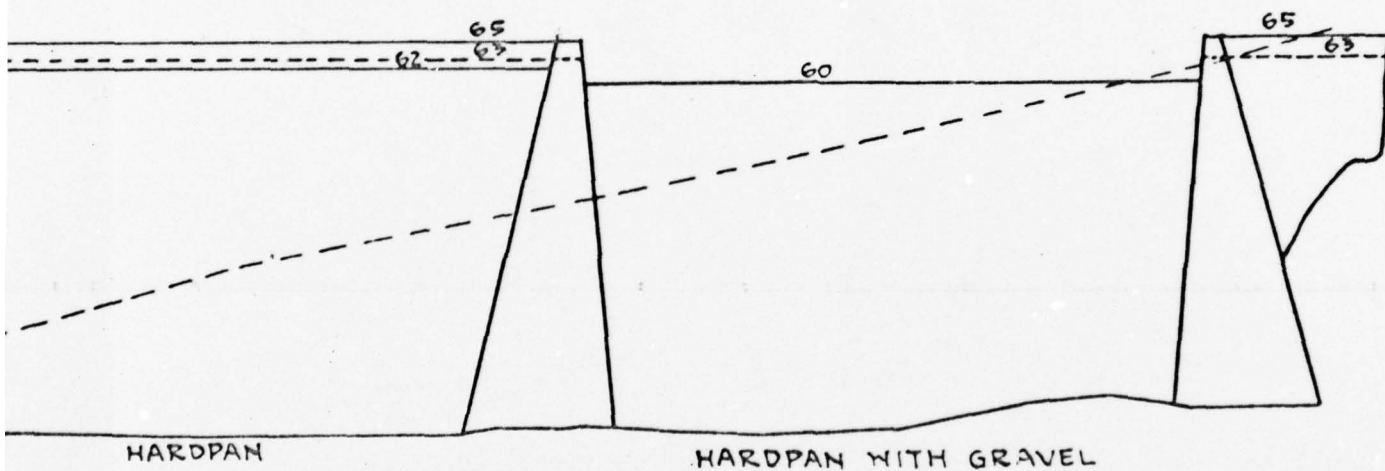
PHASE I INSPECTION REPORT
NATIONAL DAM INSPECTION PROGRAM
GARDNER CREEK DAM
PENNSYLVANIA GAS AND WATER COMPANY
PROFILE ALONG AXIS OF DAM
JUNE 1978 PLATE 3

TOP PROPOSED EMBANKMENT
TOP EXISTING EMBANKMENT

TOP OF MASONRY CORE WALL
